ENGEBØ OPEN PIT FEASIBILITY STUDY - MINING GEOTECHNICS

Prepared For
Nordic Mining ASA

SRK Consulting (UK) Limited
UK7480

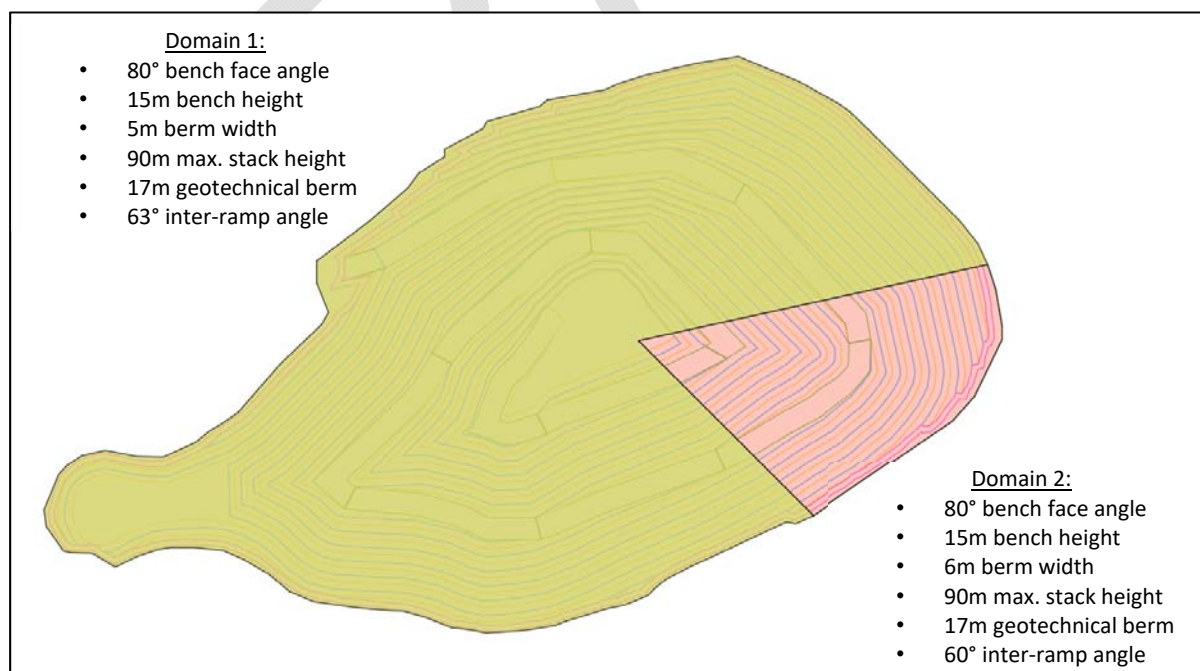
Figure ES 5: Geotechnical design domains

Based on the structural conditions, kinematic analysis and slope stability modelling SRK has identified two separate design domains (Domain 1 and Domain 2) which are differentiated as function of required berm width (Figure ES 5). Analyses show that the maximum overall slope angles for the fresh rock is constrained by the bench and berm geometry, designed to minimise kinematic instability and trap potential rock fall. It should be noted that the maximum inter-ramp stack height should be 90 m, although a flexible approach to stack height may be required to ensure practical design. If no ramp is planned within the engineered pit slope design, a 17 m geotechnical berm should be constructed at the base of the stack. If a haul ramp is located at the toe of the 90 m stack, SRK recommends that a wider 10 m berm is designed within the stack to protect the ramp from rockfall. The other alternative would be to design wider ramps that can accommodate a rock fall containment trap and catch bund.

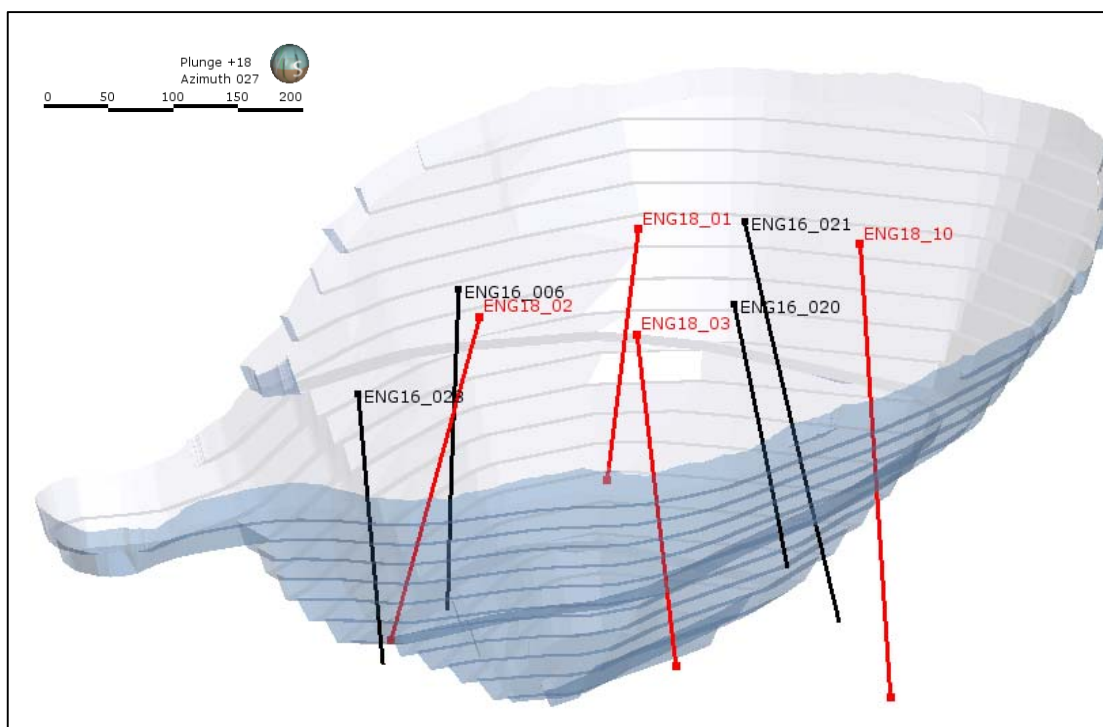
Figure 2-2: Oblique view of borehole locations. Note boreholes are placed on an interim pit shell

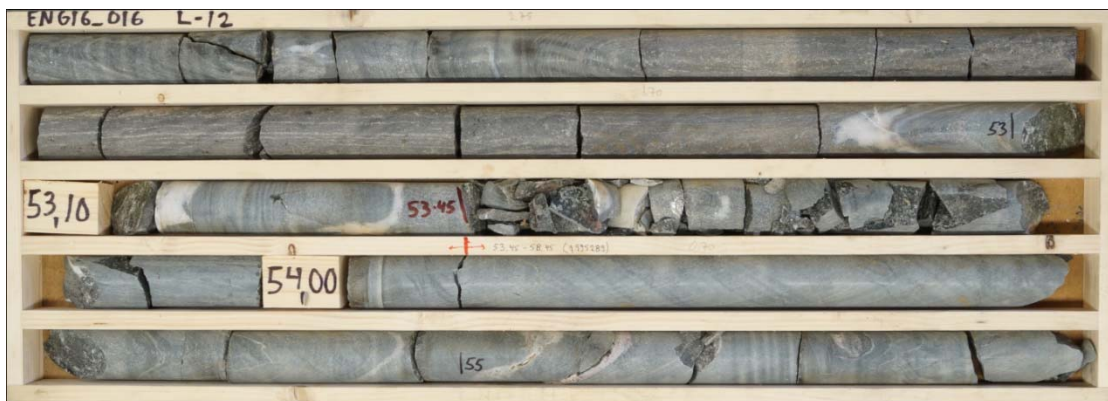
Figure 5-6: Minor fault typical of most broken intervals: fracture zone intersecting core at very low-angle; negligible fault rock

The fractures occur at a low angle to the axes of drill cores, usually indicating that they are moderate to steeply dipping. Several drill cores have semi-continuous zones of fracturing which are interpreted to result from a single fault which trend sub-parallel to the core axis, intersecting the drillhole several times.

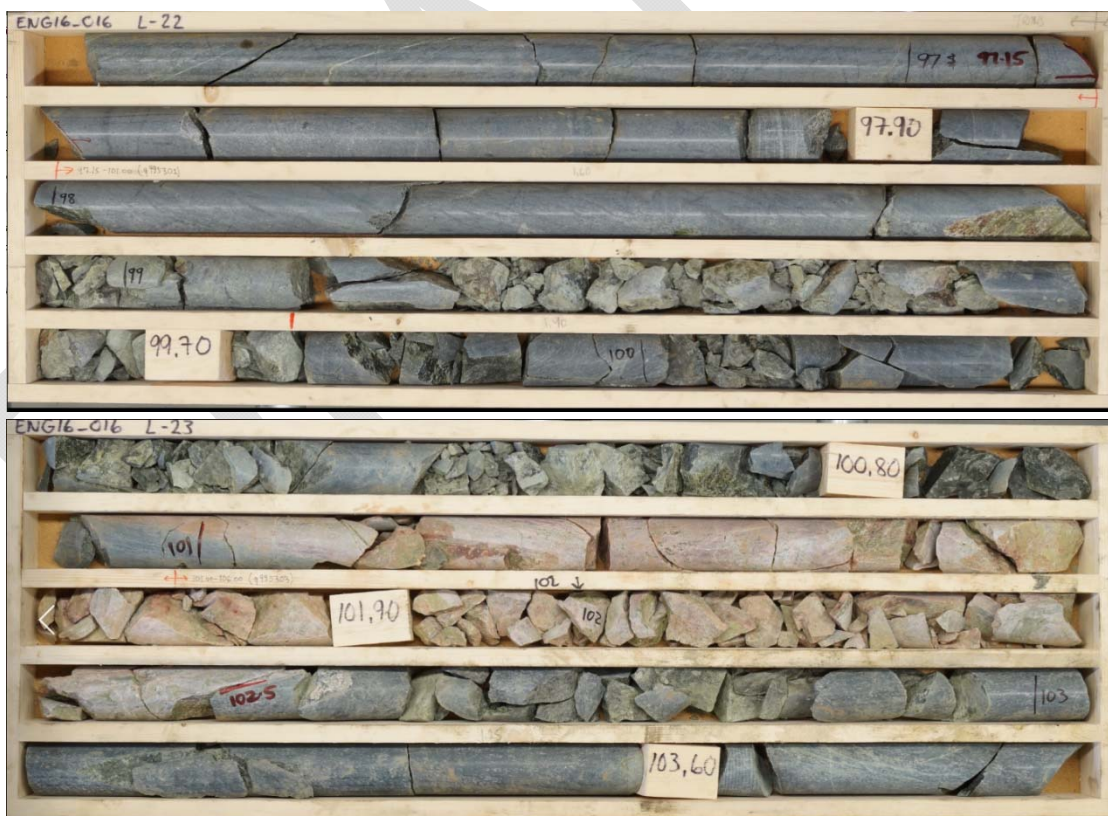
Figure 5-7: Significant fault logged in ENG16-016

Very few faulted and broken intervals were classified as moderate or major structures (<6% of all logged intervals). These intervals include strongly broken and fractured zones of eclogite as well as several intervals where there has been significant core loss or poor recovery (Figure 5-7).

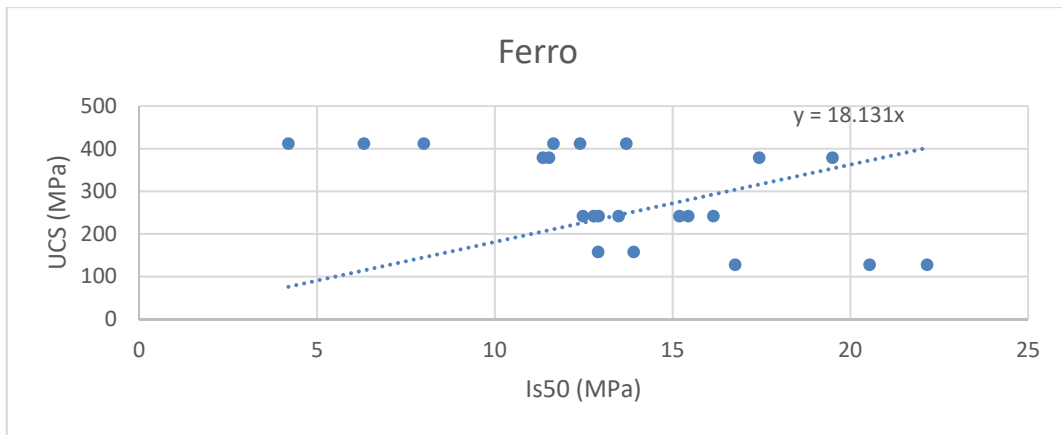
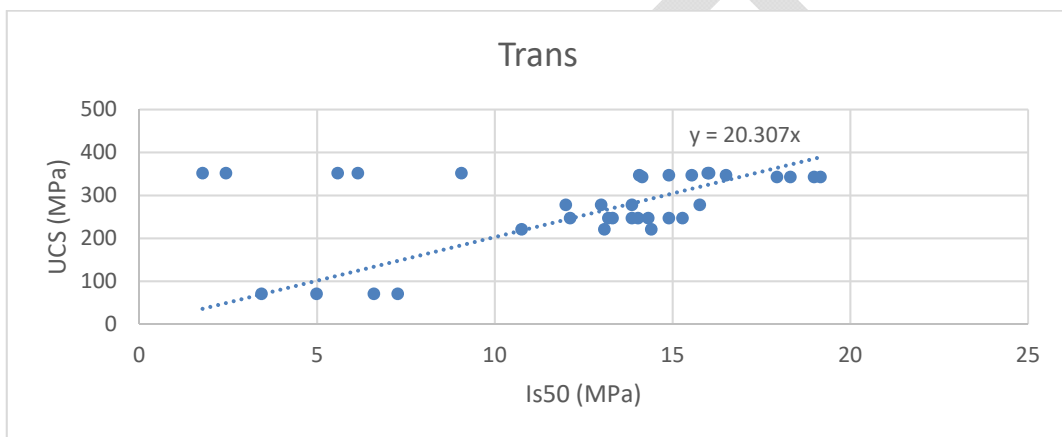
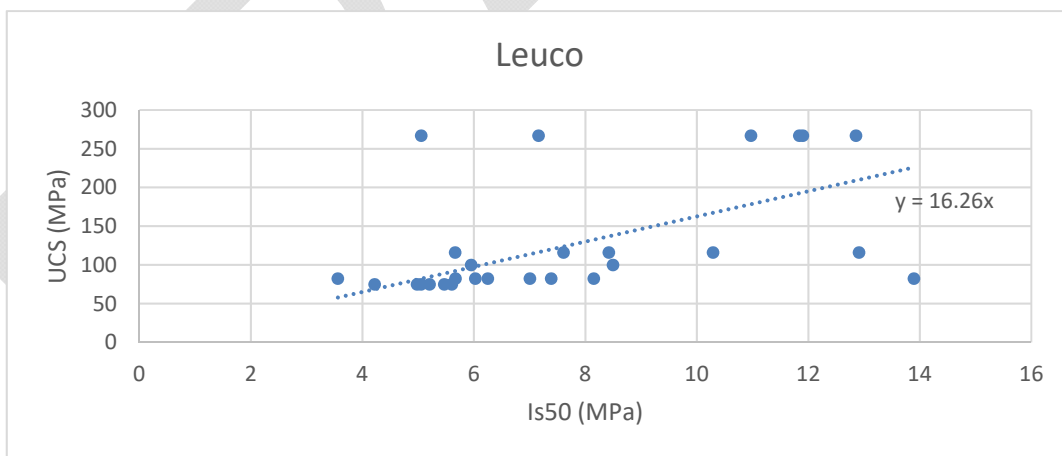
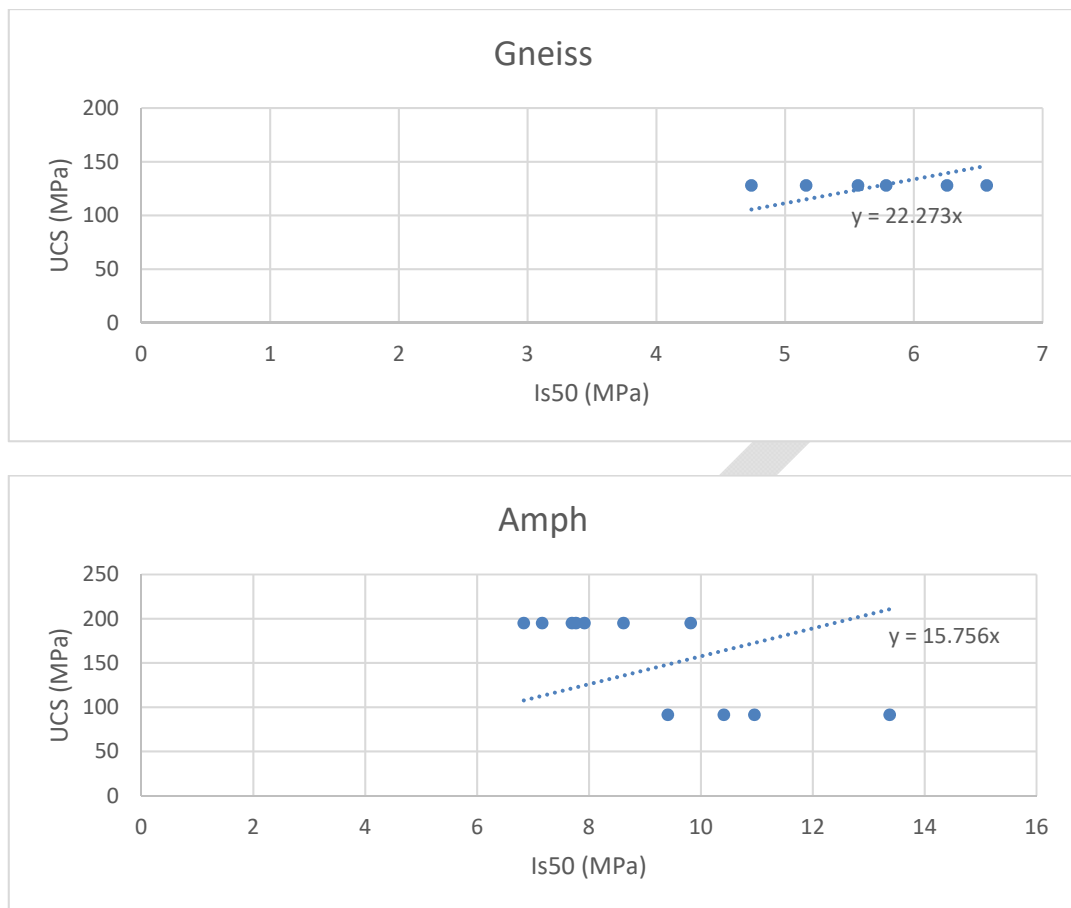
Figure 6-1: K factor generation for each major lithology

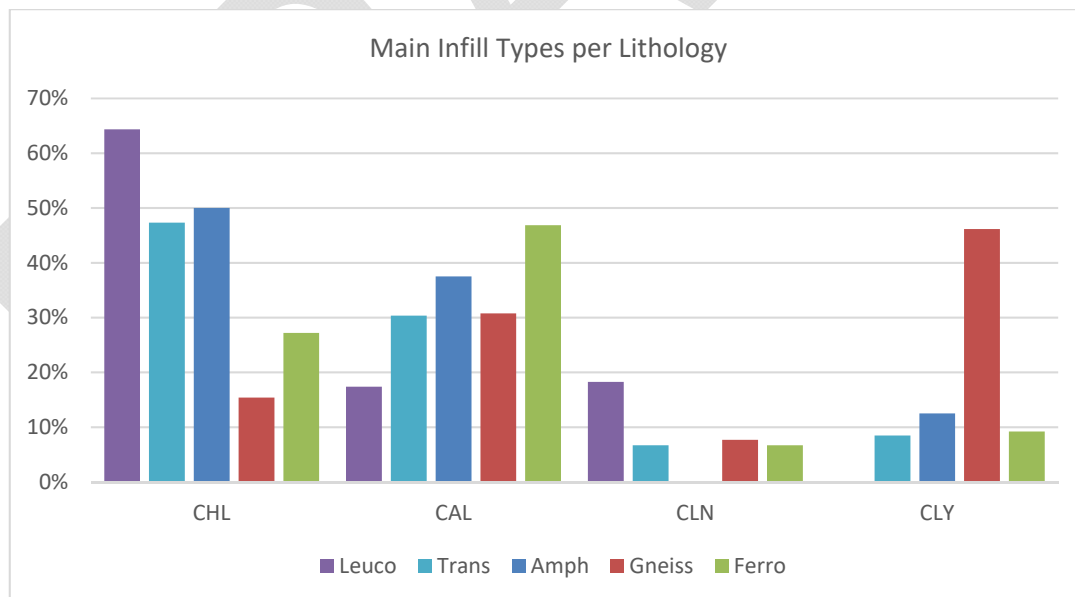
CHL=Chlorite, CAL=Calcite, CLN=Clean, CLY=Clay

Figure 6-4: Main joint infill distribution

Joint infill and surface micro roughness were recorded as part of the systematic geotechnical logging. The main infill minerals observed on joint surfaces are chlorite (40% across the pit areas) and calcite (35% across the pit areas). About 9% of all logged joints show no infill. The main infill mineral distributions for each pit area are presented in Figure 6-4. Cumulatively, these four main types of infill account for 93% of the logged infill. Joint surface roughness distributions are presented in Figure 6-5. Most of the joint logged across all pits are slightly rough and rough (49% and 24% of all joint logged respectively).

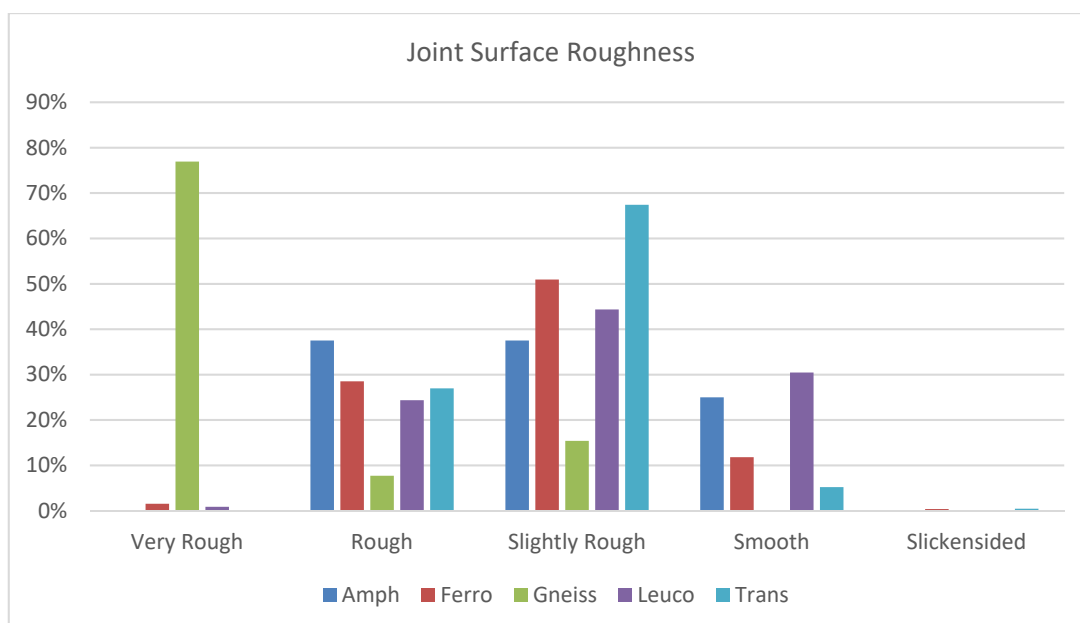
Figure 6-5: Joint micro roughness distribution

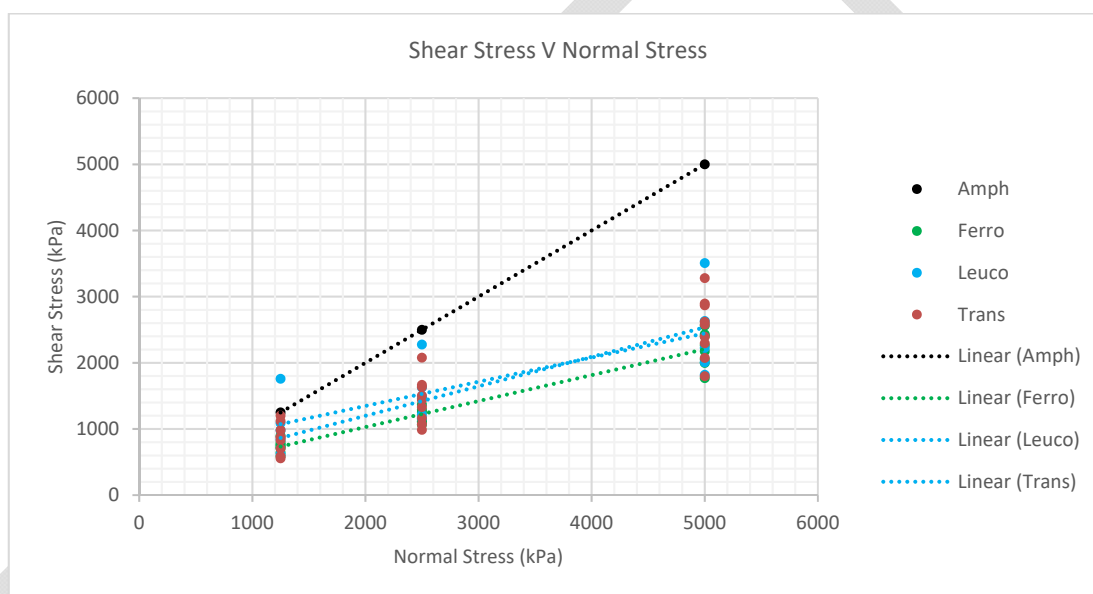
Figure 6-6: Shear/Normal plot: Joint shear strength

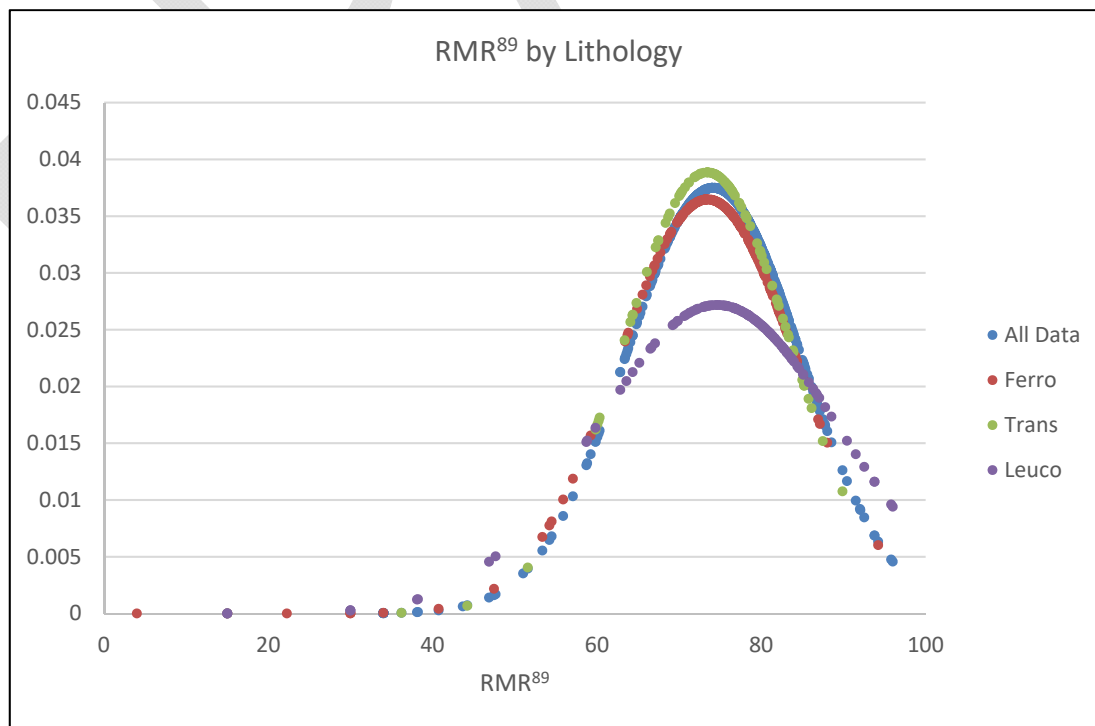
Figure 8-1: RMR⁸⁹ for each major lithology

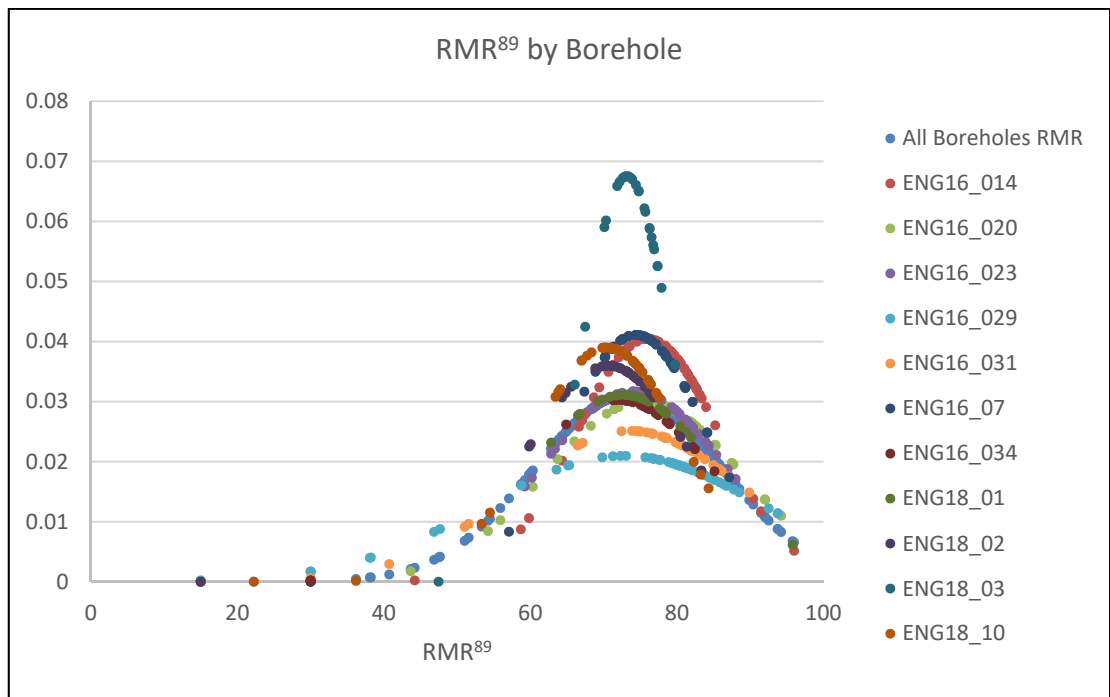
Figure 8-2: RMR⁸⁹ by borehole

Figure 8-2 shows the distribution of RMR⁸⁹ values on a borehole by borehole basis. Again, there appears to be consistency between boreholes with no specific areas of decreased ground conditions. Figure 8-3 shows the variation of RMR⁸⁹ with depth for each major lithology. With the exception of a few data points, there is little variability with depth and high RMR⁸⁹ values are intersected immediately below the topographic surface. Figure 8-4 to Figure 8-7 show representative examples of each major lithology.

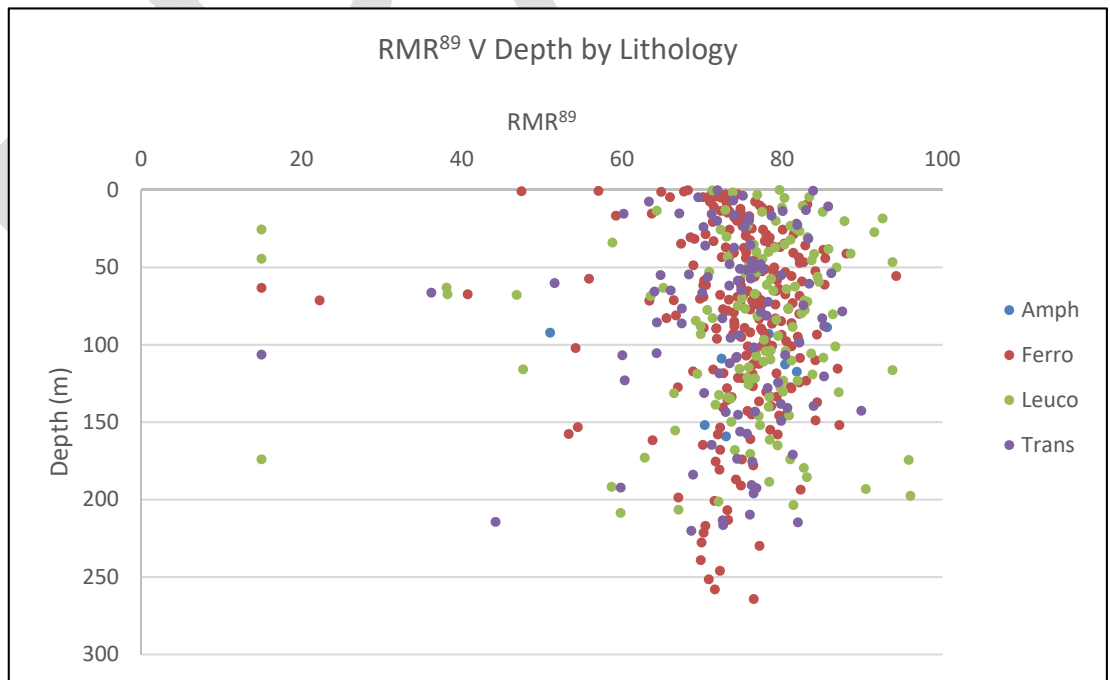
Figure 8-3: RMR⁸⁹ with depth for each major lithology

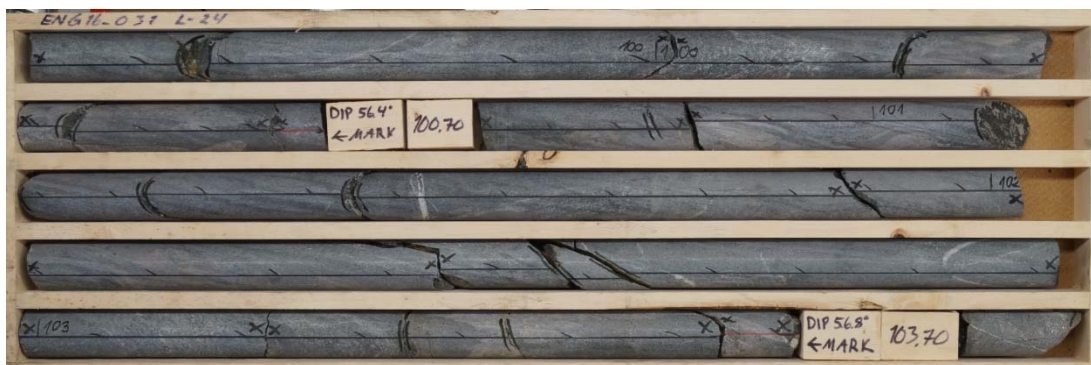
Figure 8-4: Amphibolite, Borehole ENG16-31

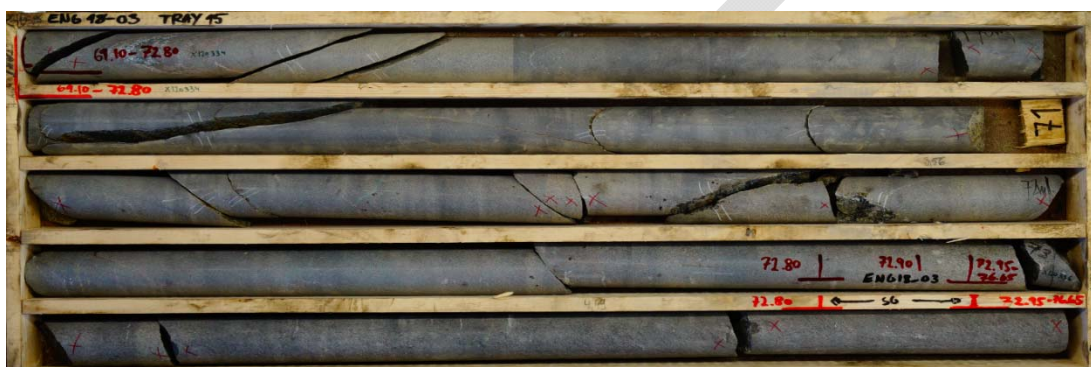
Figure 8-5: Ferro, Borehole ENG18-03

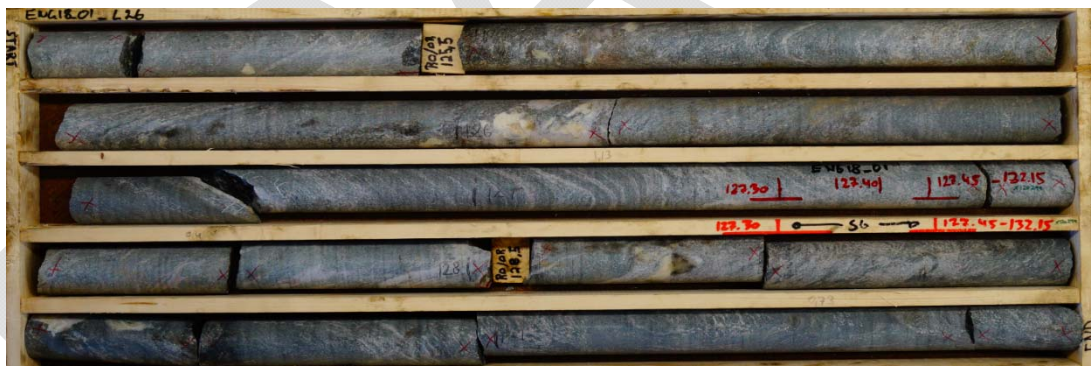
Figure 8-6: Leuco, Borehole ENG18-01

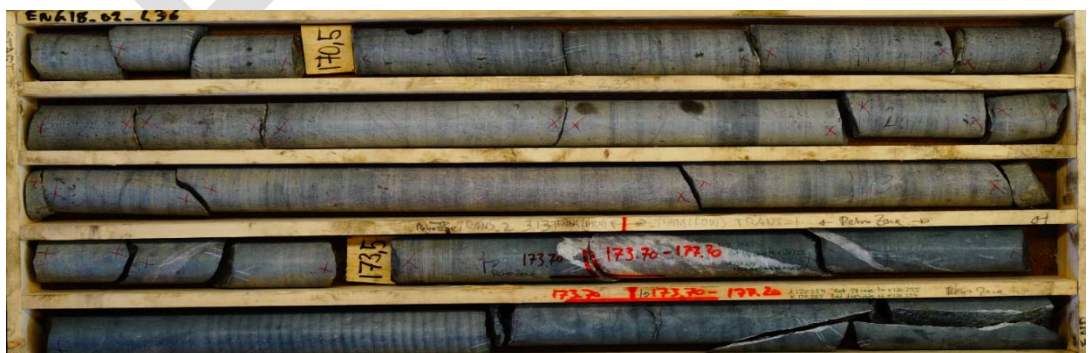
Figure 8-7: Trans, Borehole ENG18-02

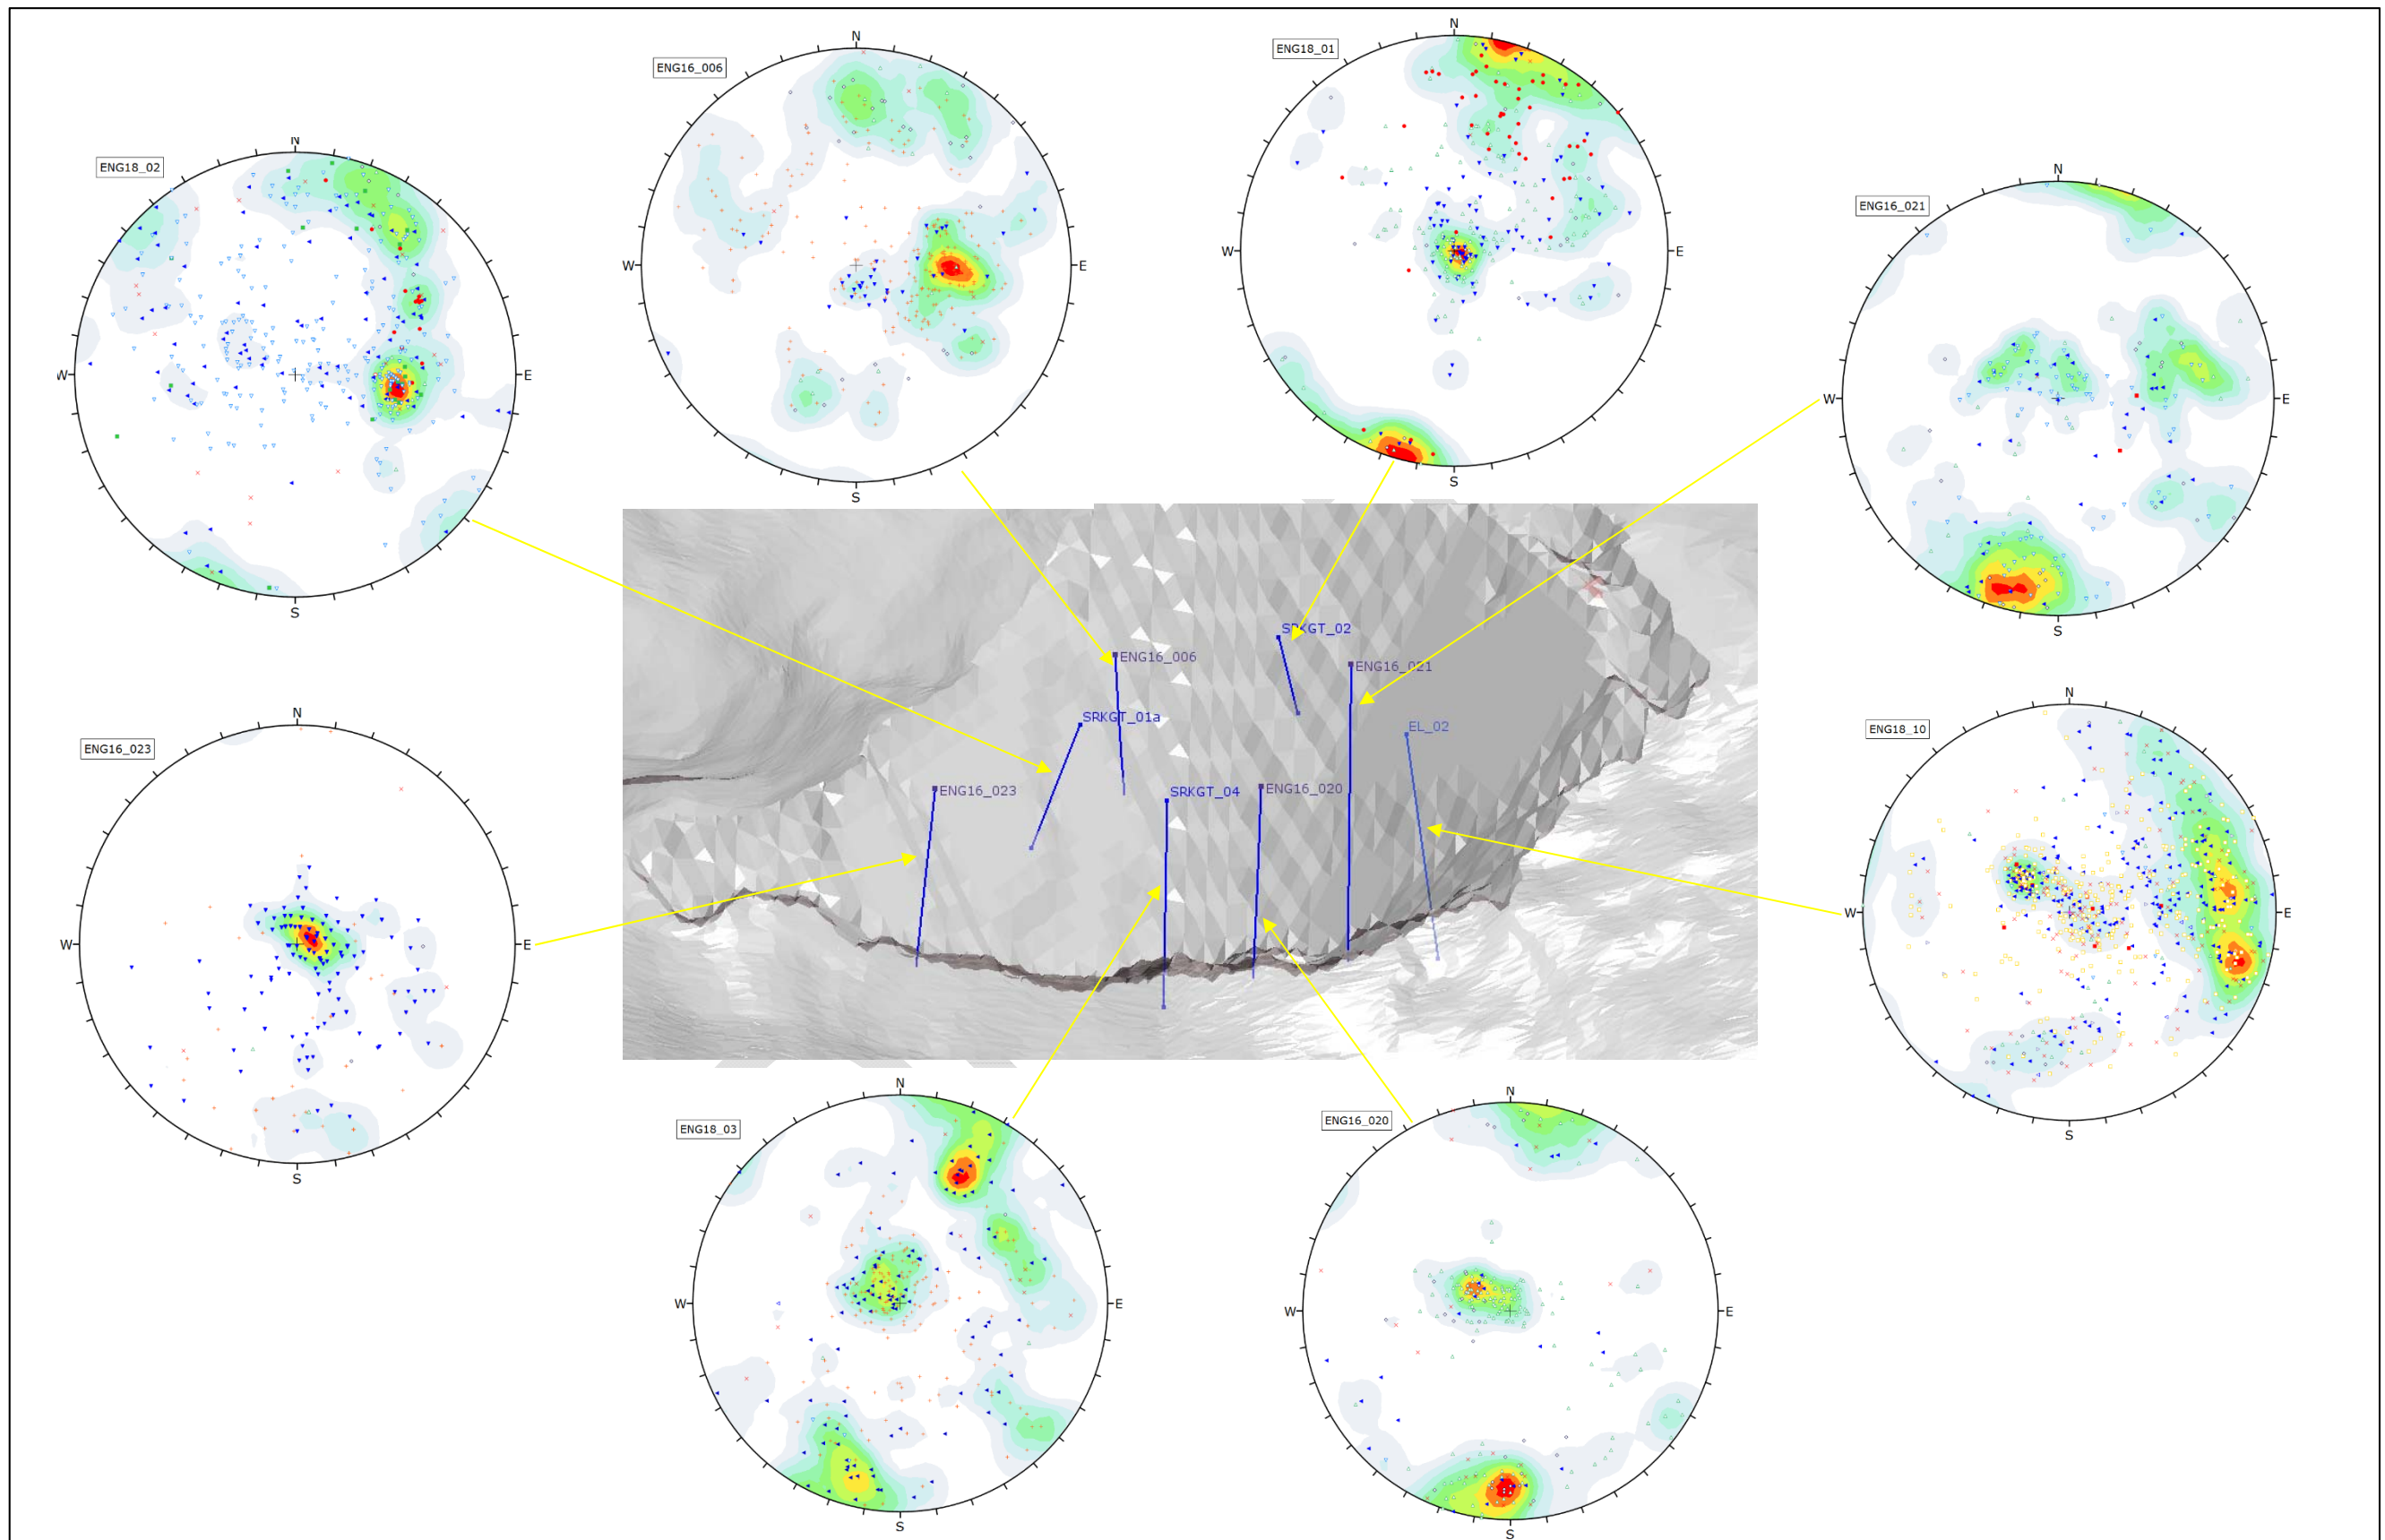
Figure 9-2: Borehole stereoplots

In general, there appears to be little structural variability between boreholes, although when such variability is evident, it is most likely a function of drill hole bias and the 'blind spot' associated with orientated core drilling. As such, SRK has combined the mid and high confidence orientation data to define a structural data set that can be considered to cover the proposed open pit slope area (Figure 9-3 and Table 9-1). No joint persistence data is available from the project area outcrops due to snow cover at the time of the site visits, although observations from the tunnel and site photographs taken when no snow was on the ground gives an idea of likely persistence. Accurate data on persistence can only be defined when fresh rock intersections are exposed during mining.

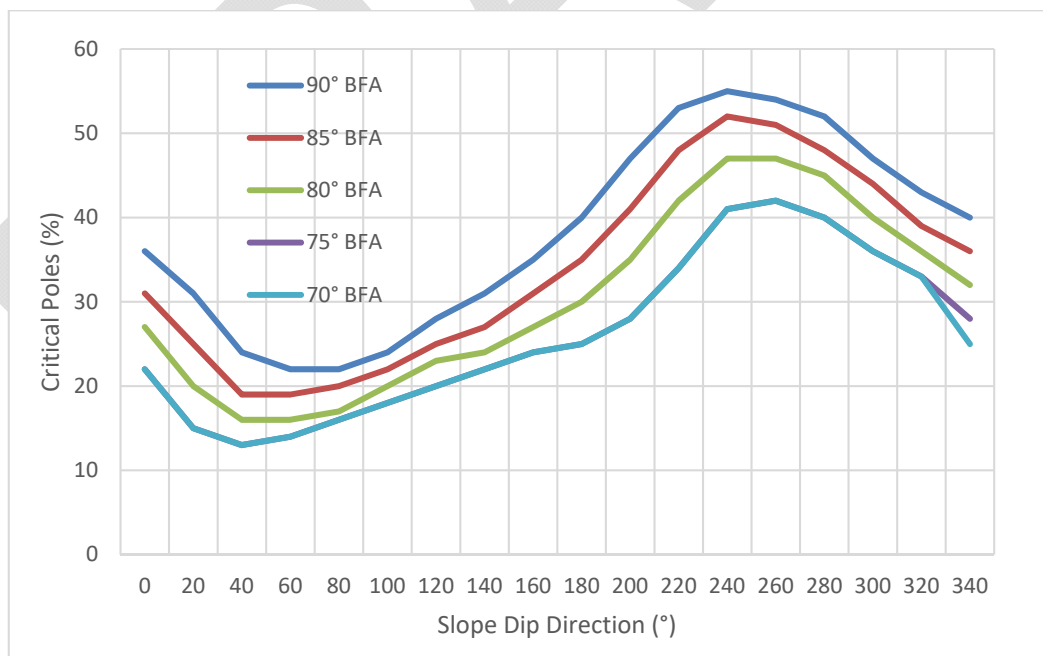
Figure 9-6: Wedge failure assessment results
