Arbeidet har foregået
 således:
 1915 — 1919 — 1923
 1916 — 1920 — Berglund
 1917 — 1921
 1918 — 1922

Maalestok 1:2000

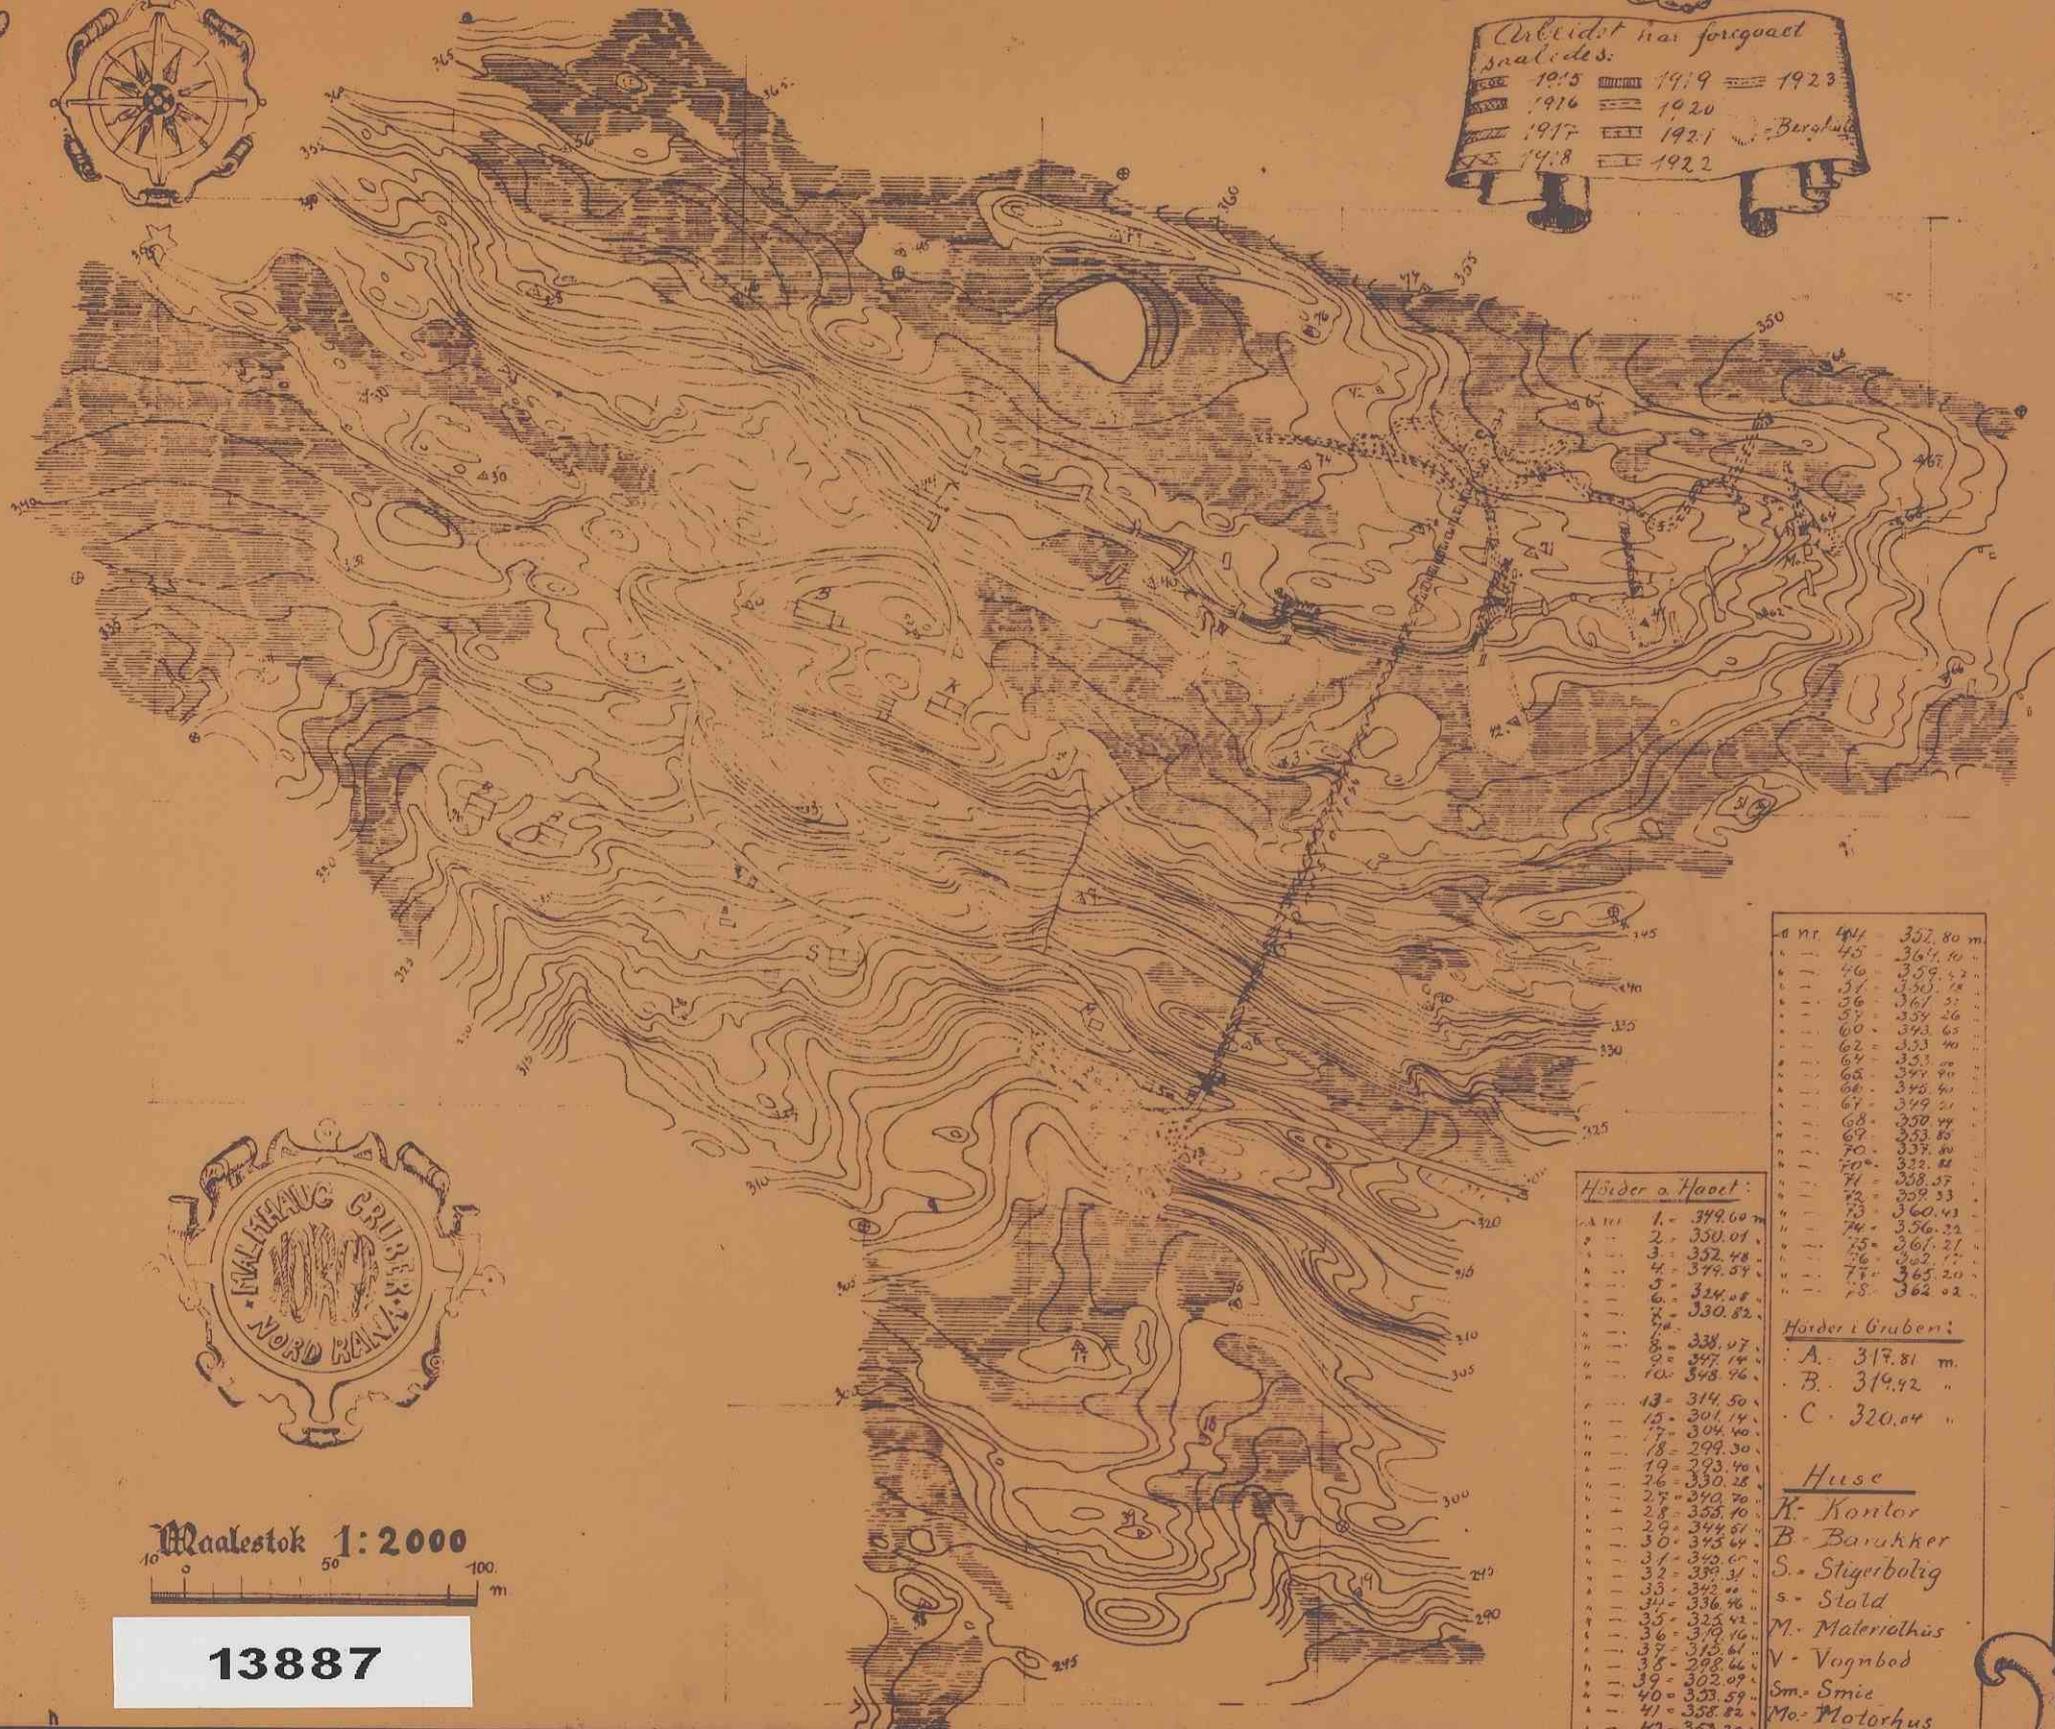
Høder a Halet:

1	349.60 m
2	350.01
3	352.48
4	349.57
5	324.08
6	330.82
7	338.97
8	347.14
9	348.76
10	314.50
11	304.14
12	304.40
13	299.30
14	293.40
15	330.28
16	310.70
17	353.70
18	344.81
19	343.64
20	345.01
21	339.31
22	342.01
23	336.76
24	325.42
25	319.16
26	313.61
27	298.66
28	302.09
29	303.59
30	358.82
31	353.20

41	357.80 m
42	364.70
43	359.72
44	350.58
45	367.26
46	373.65
47	353.40
48	353.00
49	344.90
50	348.40
51	349.21
52	350.44
53	353.80
54	337.00
55	322.01
56	308.37
57	308.33
58	360.43
59	356.22
60	361.21
61	362.17
62	365.20
63	362.02

Høder i Gruben:

A	317.81 m
B	319.92
C	320.04

Huse

- K - Kontor
- B - Barakker
- S - Stigerbalig
- s - Stald
- M - Materthus
- V - Vognbed
- Sm - Smie
- Mo - Motorhus
